Manhole Inspection Summary

Manhole # S35S1_001MH

Location Address: **201 Cherryland Rd. (in the woods east of Reedbird)** Cross Street: **Reedbird Ave.**

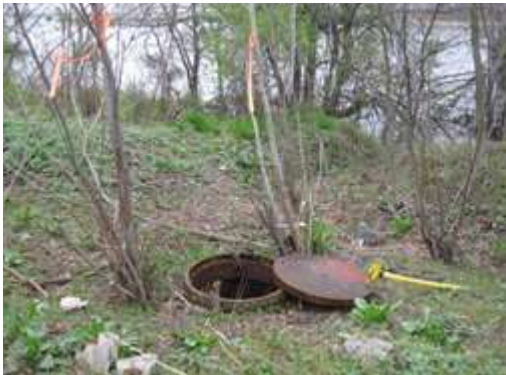
Location View

701 Cherryland Rd. (in the woods)

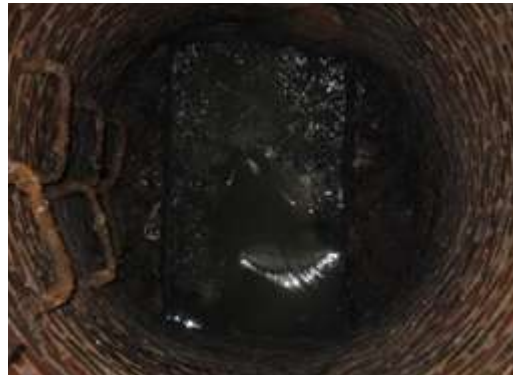
Top View

Cover Shape: **Circular** Diameter: **30** (in.) Length: (in.) Dist A/B Grade: **11** (in.)
Type: **Sanitary** Condition: **Sound** Cover Material: **Cast Iron**
Properties: ☐ Bolted ☐ Vented ☐ Water Tight ☐ Water Tight Insert

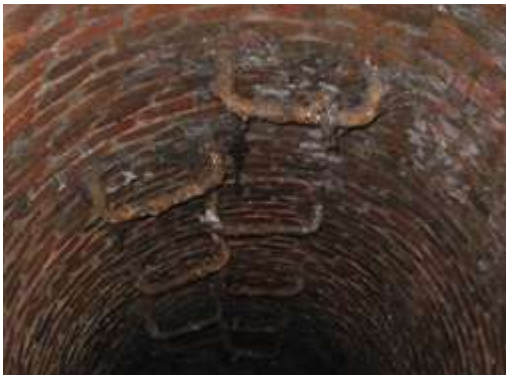
Steps Count: **10** Missing: **0** ☒ **Corroded**

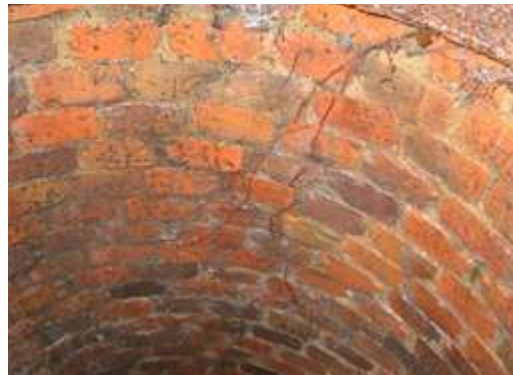
Defect 2

Corbel Material: **Brick** ☐ Parged Type: **Concentric/Eccentric**
Condition: ☒ Sound ☐ Cracked ☐ Root Intrusion ☐ Loose Brick ☐ Deteriorated
Infiltration: ☐ None ☐ Joint ☐ Cracks ☐ Mortar ☒ **Roots** ☐ Wall

Root intrusion

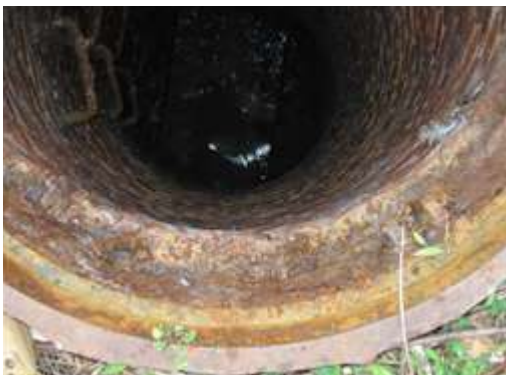
Defect 1

Frame Offset: **2** (in.) Condition: ☒ Sound ☐ Cracked ☐ Leaks

Frame offset

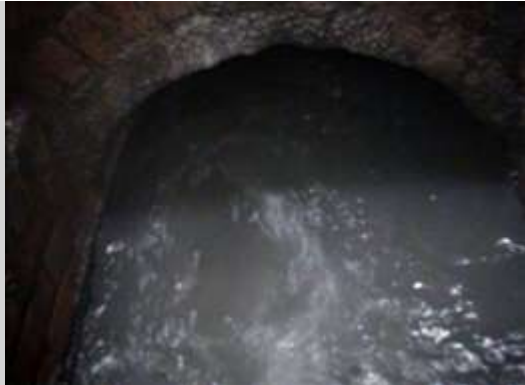
12 O'Clock Outflow

30 in. Circular Gravity Sewer
Pipe Out @ 12 O'Clock

Pipe Height: **30** (in.) Rod and Bar (Angled)
Pipe Material: **Concrete** ☐ Pipe Lined
Invert Depth: **18.90** (ft.) Flow Characteristics: **Fast**
Deposits: ☒ None ☐ Mud ☐ Sludge ☐ Debris ☐ Grease
Silt Depth: (in.) Deposits Extent:
Infiltration: **None** Pipe Seal Cond: **Sound**

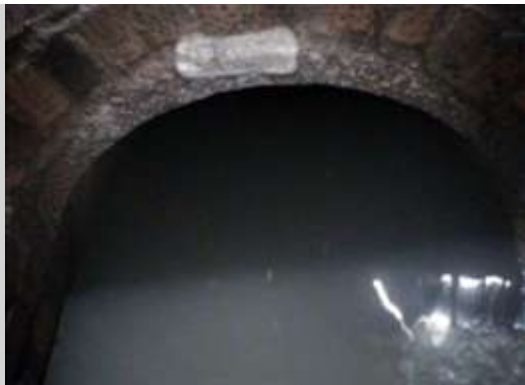
6 O'Clock Inflow

30 in. Circular Gravity Sewer
Pipe In @ 6 O'Clock

Pipe Height: **30** (in.) Rod and Bar (Angled)
Pipe Material: **Concrete** ☐ Pipe Lined
Invert Depth: **18.64** (ft.) Flow Characteristics: **Fast**
Deposits: ☒ None ☐ Mud ☐ Sludge ☐ Debris ☐ Grease
Silt Depth: (in.) Deposits Extent:
Infiltration: **None** Pipe Seal Cond: **Sound**
